**KOMITE NASIONAL KESELAMATAN TRANSPORTASI
REPUBLIC OF INDONESIA**

KNKT.21.01.01.04

Aircraft Accident Investigation Report

Boeing 737-500; PK-CLC

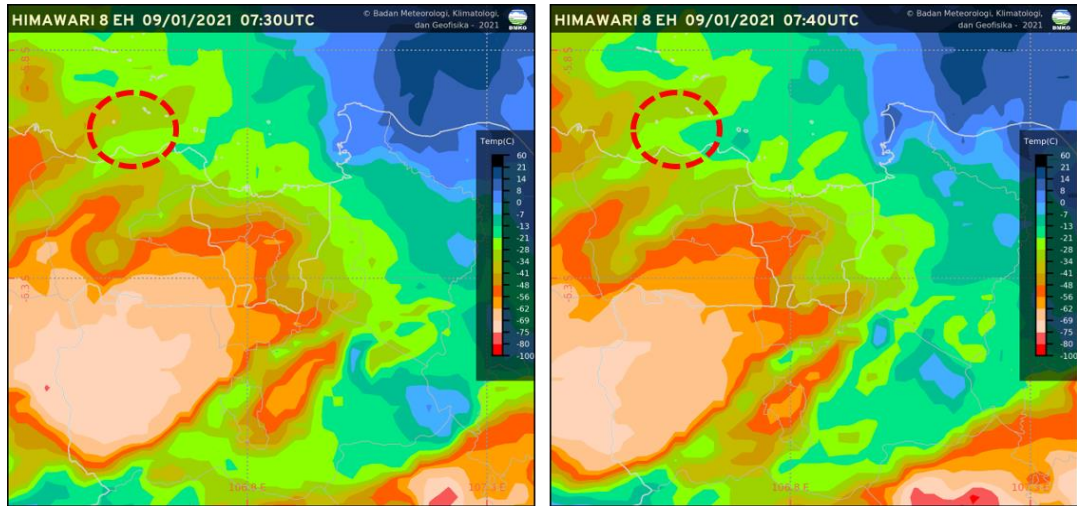
The *Badan Meteorologi Klimatologi dan Geofisika* (BMKG – Bureau of Meteorology, Climatology and Geophysics) provided enhanced infrared satellite images. The enhanced infrared satellite images at 0730 UTC (1430 LT) and 0740 UTC (1440 LT) indicated that the cloud top temperature at the accident site (red circle) was from -34°C to -21°C .

Figure 1: Enhanced infrared satellite image at 0730 UTC and 0740 UTC at accident site (red-dotted circle)

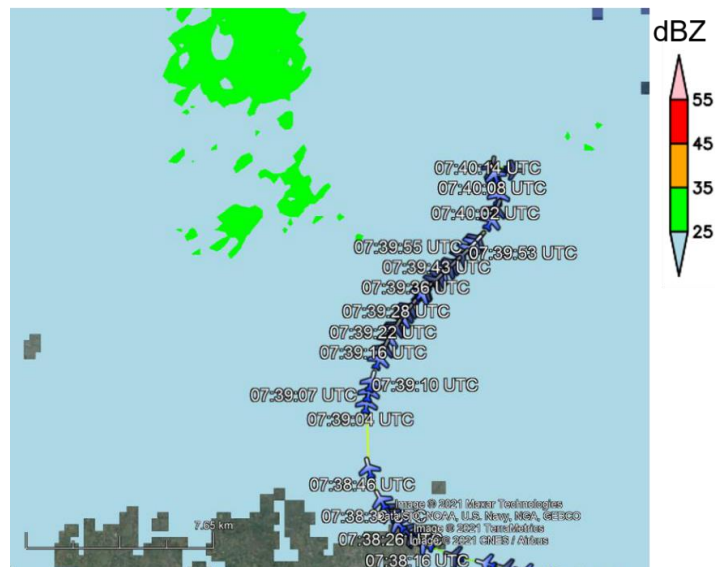
The superimposed ADS-B-based flight profile with radar weather image at 1438 LT provided by the BMKG indicated that the radar intensity level along the flight profile was not more than 25 dBZ⁹, which means that the flight path did not indicate any significant development of clouds.

Figure 2: The superimposed ADS-B-based flight profile with BMKG radar weather image at 1438 LT

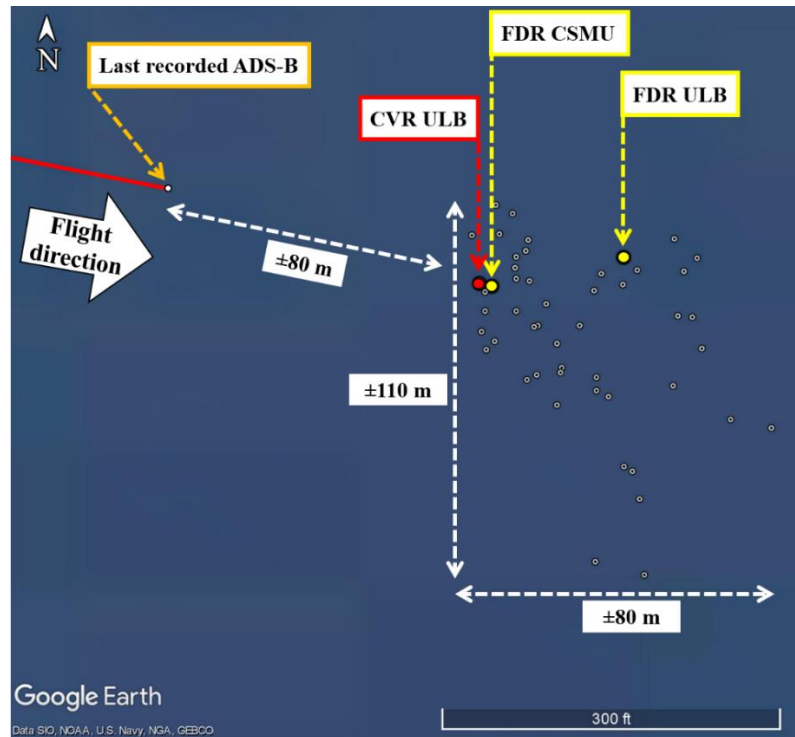
The search team identified that the wreckage was about 80 meters south east from the last known aircraft position recorded by the ADS-B. The wreckage was distributed across an area of about 80 by 110 meters on the seabed at a depth of approximately 16 meters.

Figure 4: Location of FDR CSMU, FDR ULB and CVR ULB relative to the last ADS-B recorded data

The FDR's CSMU was found within the wreckage distribution area at coordinate 5°57'51.00" S 106°34'31.00" E. The ULBs were detached from both the FDR and the CVR¹⁰. The FDR's ULB was found at coordinate 5°57'50.76" S 106°34'32.10" E approximately 35 meters from the FDR's CSMU, and the CVR's ULB was found at coordinate 5°57'50.98" S 106°34'30.90" E.

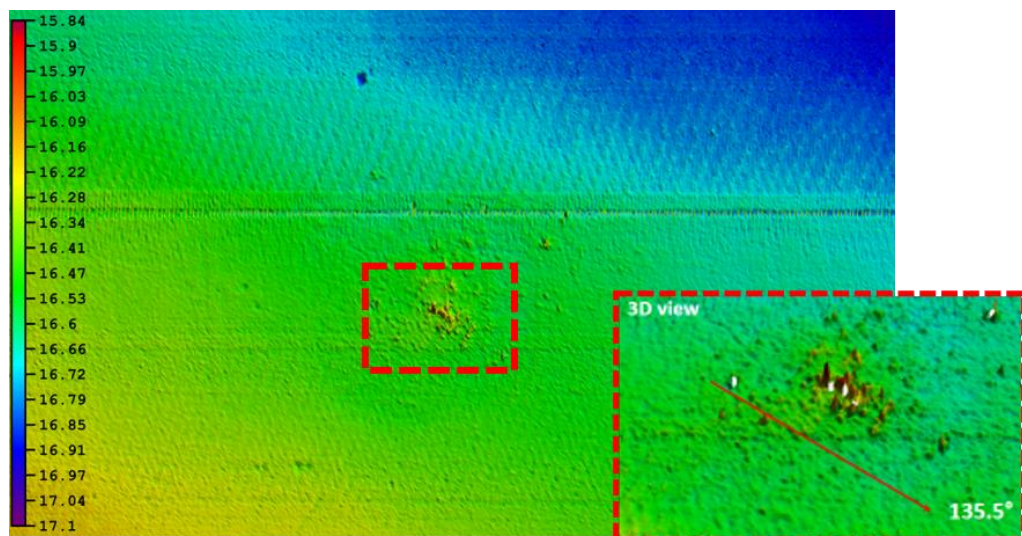
Figure 5: Scanning result from multibeam echosounder
